National Highway Traffic Safety Administration

Case Vehicle (A): 1999 Chevrolet

Vehicle (B): 1996 Chrysler Type: Silverado, 4x4 extended cab pickup Type: Concorde, 4-door sedan

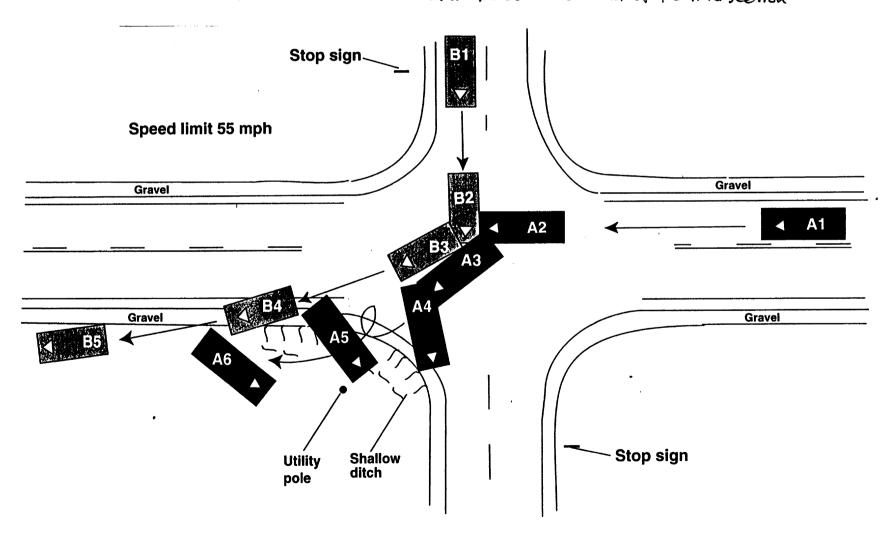
ACCIDENT DESCRIPTION: (ase vehicle (A) was traveling westbound on a 2-lune CASE VEHICLE (A) 1999 Chevrolet Silverado road way, approaching a 41eg intersection. Vehicle (B) was traveling south sound on the OTHER VEHICLE (B): 1996 Chrysler Concorde intersecting 2-lane roadway. As case vehicle (A) entered the intersection vehicle (B) also entered the intersection and crossed the path of case vehicle (A). Case vehicle (A) struck the left side of vehicle (B) with its front end. The impact caused vehicle (B) to enter a clockwise rotation and case vehicle (A) to enter a counterclockwise rotation pin a side-slap impact between the two vehicles. Vehicle (B) crossed the east bound traffic lane and exited the intersection.

Through the west lead deported the randown and came to a rest. (ase vehicle (A) departed roadway where it tripped, right side leading NORTH a rolled 4-quarter turns. Case vehicle (A) came to rest on its wheels at the southwest corner of the intersection.
